# FACILITY COMPLIANCE INSPECTION REPORT

## Division of Waste Management Solid Waste Section

**Date of Site Inspection:** 12/5/2012

Yancey-Mitchell Transfer Station  
555 Landfill Road (SR-1440)  
Burnsville, NC 28714

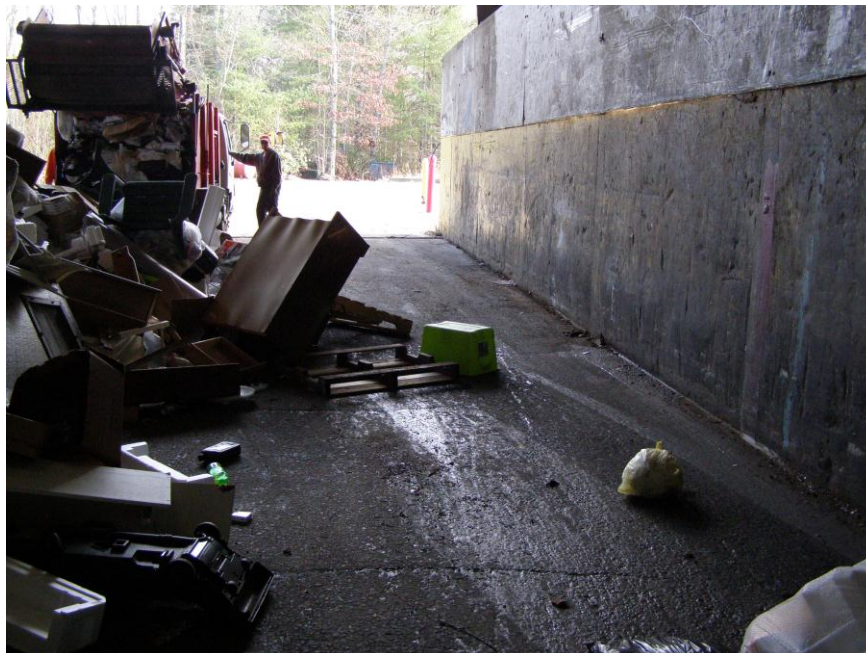
13. One area of the tipping floor could be observed during the inspection. Cracks were visible and there appeared to be extensive wear in floor in that area. There was no movement of broken concrete observed in the surface layer. Should the tipping floor base layer be compromised below the cracked surface it would be possible for leachate to be released underneath the building and outside the leachate collection system. Any release of leachate outside of the collection system would be a violation of the Solid Waste Management Rules and could require corrective actions. The entire floor should be monitored for damage and repairs scheduled as needed.

View of cracks visible at the surface of the Tipping Floor. Digital photograph taken by D. Aja on 12/5/2012.

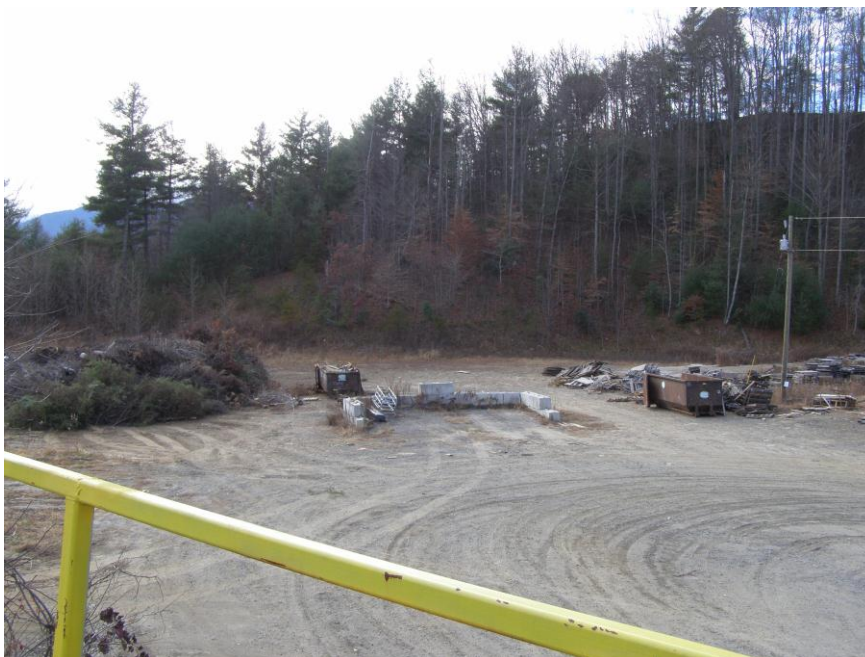
19. A metal safety rail was installed at edge of the metal loading area (visible in foreground of the photograph of the treatment and processing area, below).

20. There were no containers or designated areas provided for banned wastes or recyclables such as electronics and tires.
21. The treatment and processing area was observed. A few pieces of treated wood were observed at the outer edge of the pile of unprocessed wood waste. A container was in place next to the pile for the removal of incidental unacceptable wastes delivered to this area. The remainder of the unprocessed wood waste accumulated at the site appeared to be acceptable wastes. It appears that great improvements have been made in the operations of the treatment and processing area and the area was operated as required.

View of Treatment and Processing Area. Digital photograph taken by D. Aja on 12/5/2012.
